# Sprague GeoServices

RE: Removal and Polyencapsulation of  
Petroleum Contaminated Soil  
Ben & Jerry's Homemade Inc. Plant  
Waterbury, Vermont

## 1.0 INTRODUCTION

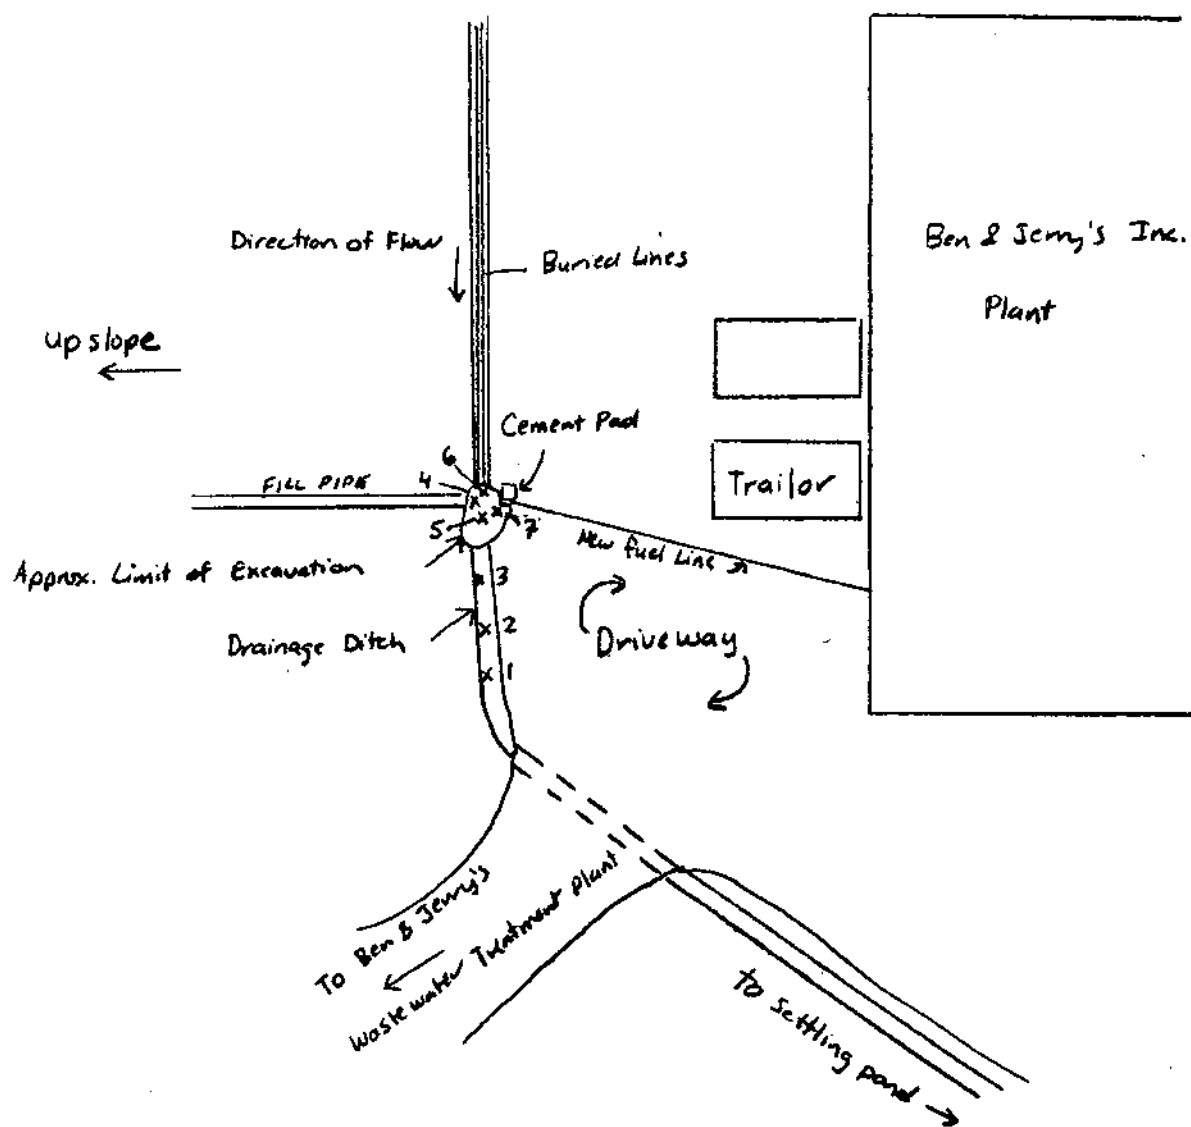
FIGURE 1

On April 28, 1998, Ben and Jerry's Homemade Inc. personnel collected soil samples in the vicinity of the fill pipe using a hand shovel. Sprague GeoServices monitored the soil samples using a PID to determine total VOC concentrations. In order to determine the down-gradient extent of the petroleum contamination, the soil sampling was initiated in the drainage ditch, approximately 30 feet down-gradient of the fill pipe. A soil sample was collected from a depth of approximately 12 inches below the bottom of the ditch and placed in a plastic bag. The total VOC concentration of the soil headspace was measured with a PID in accordance with the procedures outlined in the "Agency Guidelines." This headspace screening procedure was continued at approximately 10-foot intervals up to the area of the fill pipe. The total VOC concentrations ranged from 2.8 to 3.2 ppm in the area 10 to 30 feet down gradient of the fill pipe. The headspace of the soils in the immediate area of the fill-pipe ranged from 18 to 47 ppm. A summary of these findings is presented in Table 1, and a sketch map of the area is presented as Figure 1.

Sample #	Head Space PID (ppm)	Location
1	2.2	Drainage ditch 30' down gradient of fill pipe
2	3.1	Drainage ditch 20' down gradient of fill pipe
3	2.8	Drainage ditch 10' down gradient of fill pipe
4	47	Drainage ditch near fill pipe
5	18	Drainage ditch just down gradient of fill pipe
6	43.1	Drainage ditch just up gradient of fill pipe
7	42	In excavation

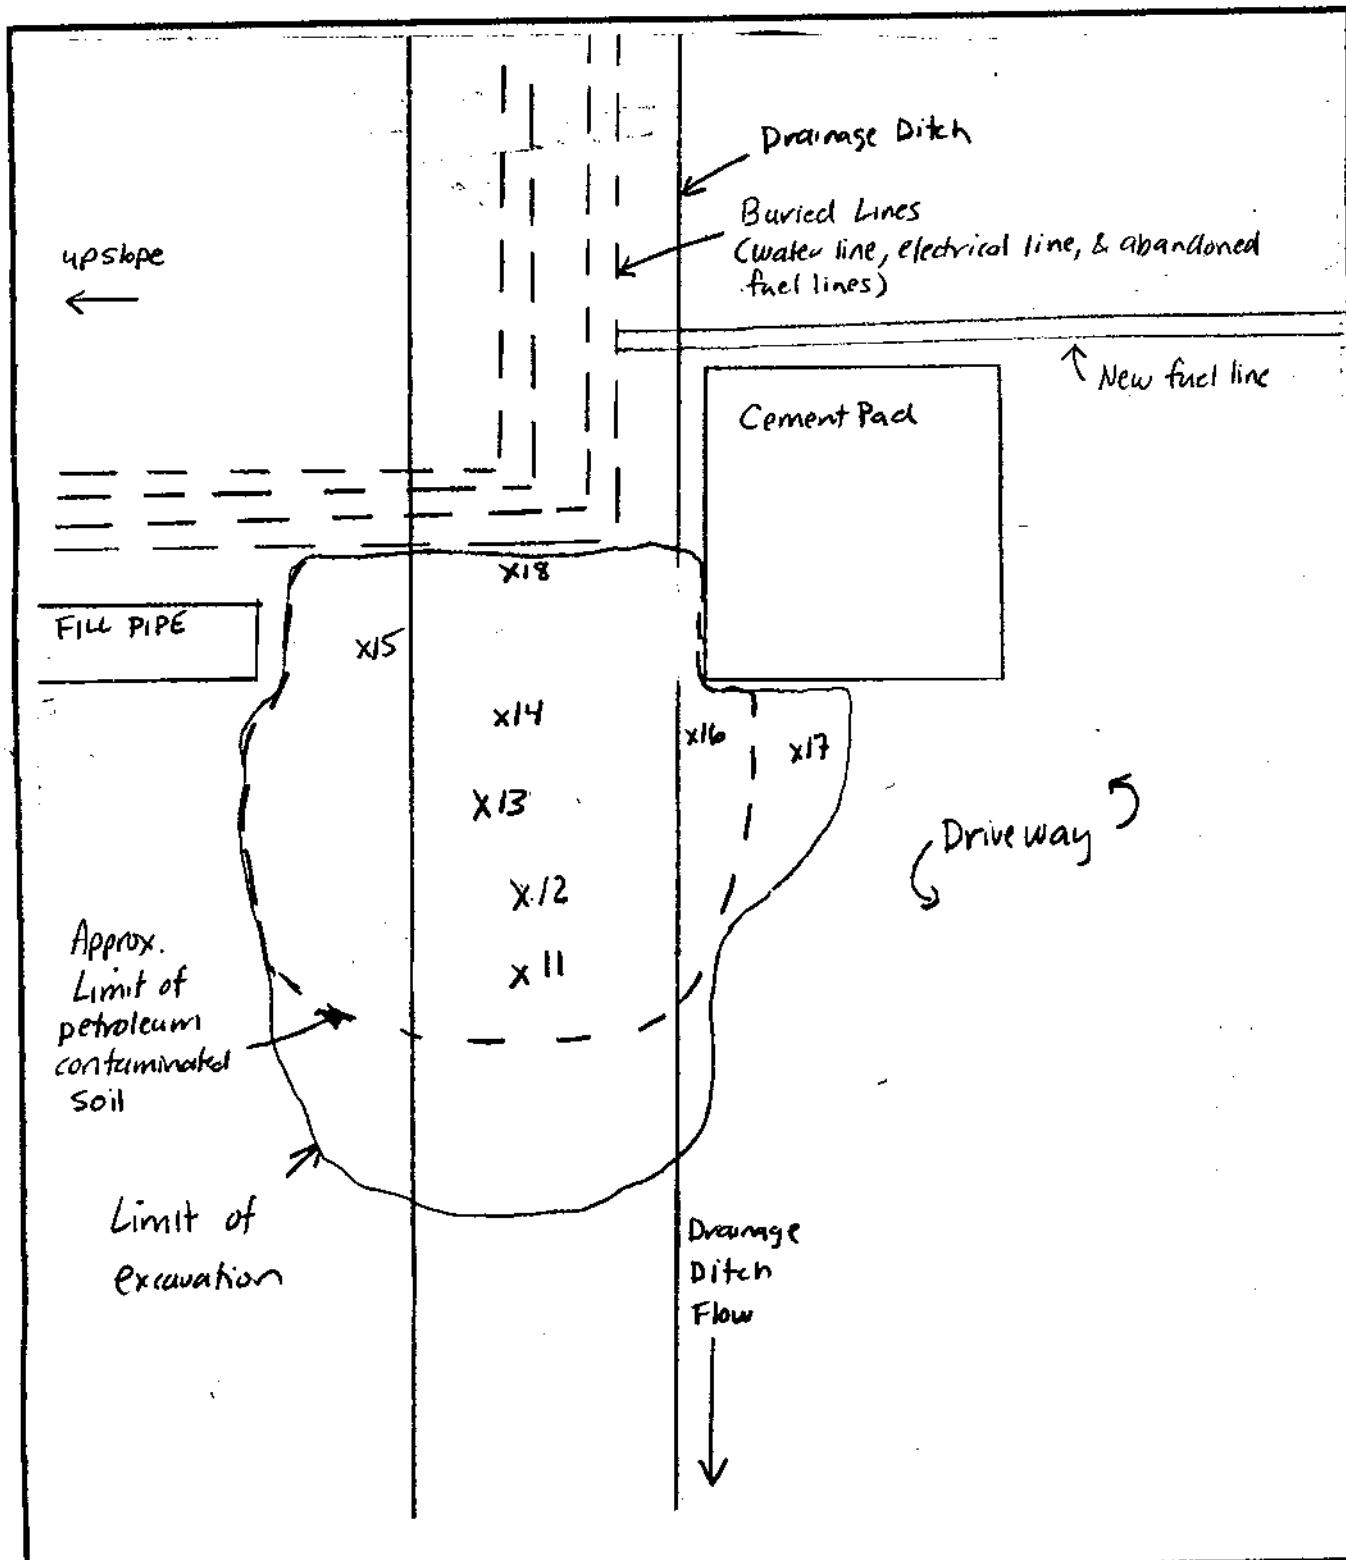
FIGURE 2

On May 8, 1998, excavation activities in the vicinity of the fill pipe continued. A layer of black stained sandy soil was observed in the area below the fill pipe, at a depth of approximately 1-1.5 feet below the top of the drainage ditch. The soil had a strong petroleum odor, with PID readings on the order of 14 to 85 ppm (Table 2). The soils below the black-stained petroleum contaminated soil were brown/tan colored. The soil sample collected from this layer had a PID headspace reading of only 2-3 ppm, suggesting that the petroleum contamination does not appear to extend vertically downward below approximately 1.5 to 2.5 feet (Figure 2).

(approximately 3-4 feet wide). The vertical extent of the petroleum contaminated soil is thought to be approximately 1.5 to 2.5 feet deep, as witnessed by the brown/tan soil (PID 2-3 ppm) below the black-stained soil. Although the bulk of the contaminated soil is thought to have been removed, it was not possible to excavate all the contaminated soil in the up-gradient direction of the ditch due to the proximity of numerous buried lines, including a water line, electrical line and the abandoned fuel lines. The PID headspace concentration of the soils collected from this area (the limit of the excavation in the up-gradient direction) was 14 ppm. Given that this is significantly lower than the peak PID concentration of 85 ppm, it appears that the level of petroleum contamination is declining in the up gradient direction (Figure 2).

Sample #	Head Space PID (ppm)	Soil Screening PID (ppm)	Location
11		20	Black stained soil in drainage ditch just down gradient of fill pipe
12		30	Black stained soil in drainage ditch just down gradient of fill pipe
13	2		Brown/tan soil below black stained soil
14	15		Black stained soil below fill pipe
15	85		Black stained soil below fill pipe
16	85		Black stained soil near concrete pad (petrol odor)
17	2		Black colored soils SE of concrete pad (no odor)
18	14		Brown/tan soil in drainage ditch 3 feet up gradient of fill pipe. (Limit of up gradient excavation due to presence of buried lines in ditch)
